THE ARTIFACT, ITS CONTEXT AND THEIR NARRATIVE: MULTIDISCIPLINARY CONSERVATION IN HISTORIC HOUSE MUSEUMS

The Walls Can Speak - Understanding the Narrative of the Historic Interior as an Architectural Artefact

Introduction: Kasteel Keukenhof

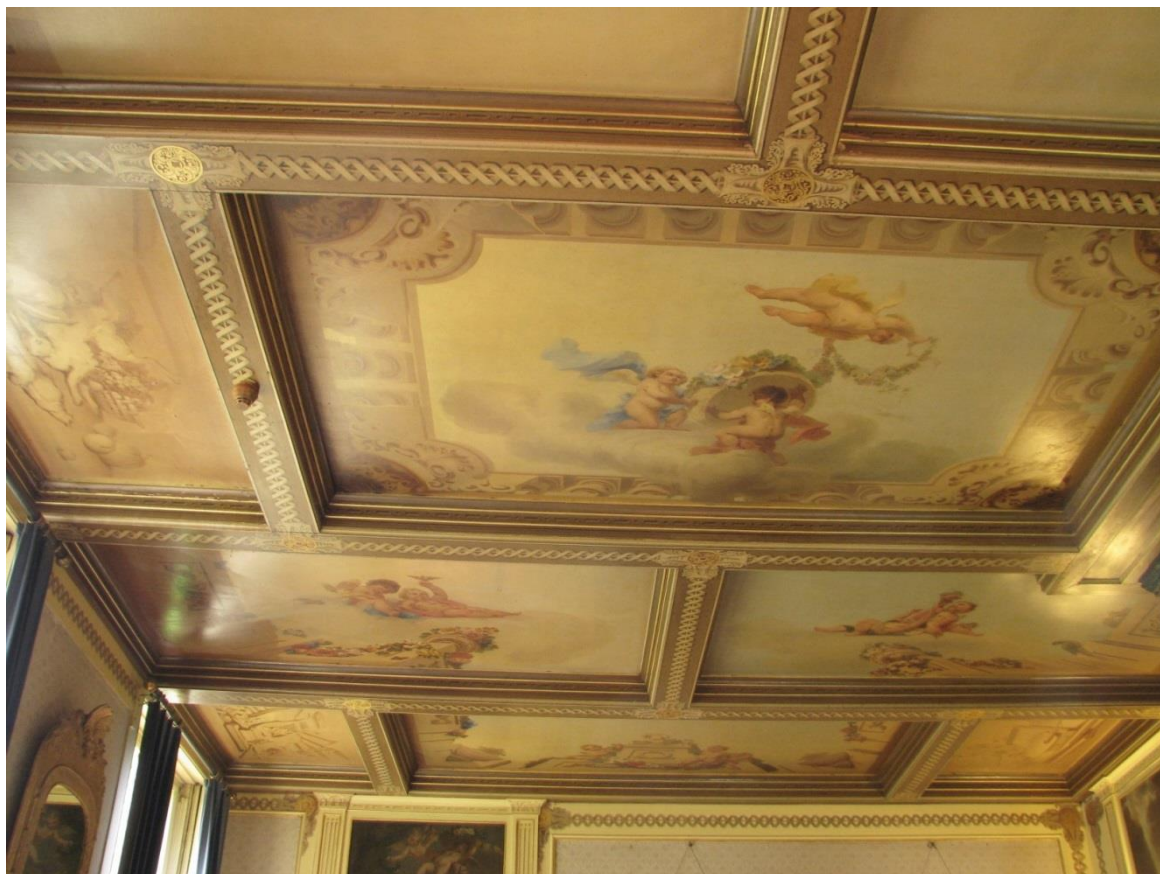
Fig. 2. Blue Salon: detail of the ceiling and walls with the decorative strap-work. ©E. Geldhof/R. Keppler

The Blue Salon is the most representative room of the castle. The architectural outline of the room is part of the seventeenth century floor plan. The room is situated on the *piano nobile*. Its most prominent features are the early eighteenth century mantelpiece decorated with a blue veined faux marble, and the coffer ceiling in which twelve paintings by Johannes Stortebecker (1821-1899) are recessed. The decorative strap-work (painted in a dark faux-wood on linen and cut out) is glued on the painted light yellow wainscoting. This dark linen strap-work on a light coloured background on the panelling is mirrored in the ceiling. Here, a light coloured decoration is painted on the dark wood imitation of the beams in the ceiling. (Figure 2) The current light

If the aesthetical values of the room are observed, it is clear that the linen strap-work on the wooden panelling has a three-dimensional purpose. The dark strips applied on the light background, enhanced with a painted shadow line, give the panelling its architectural three-dimensional features. This pattern is repeated, but mirrored in the ceiling where the decorative motive is painted directly on the wooden beams. Thus, the decorative strap-work on the panelling forms a unity with the painted decoration on the ceiling. If the strap-work was initially glued on dark green painted panelling and later replaced on the light yellow panelling, traces of dark green paint on the reverse of the strips might be expected. Investigation of a few loose linen strips did not show any residues of green paint. Stylistically, it also seems strange to have a dark green panelling with dark decorative strips on it. This would not give as much of a visual three-dimensional effect in the room as it has now (intangible aspects - the synergy). Understanding and clarifying this stylistic aspect of related decorative elements allowed the authors to preserve this light yellow colour, maintaining this decorative scheme and the synergy of the room for future generations.

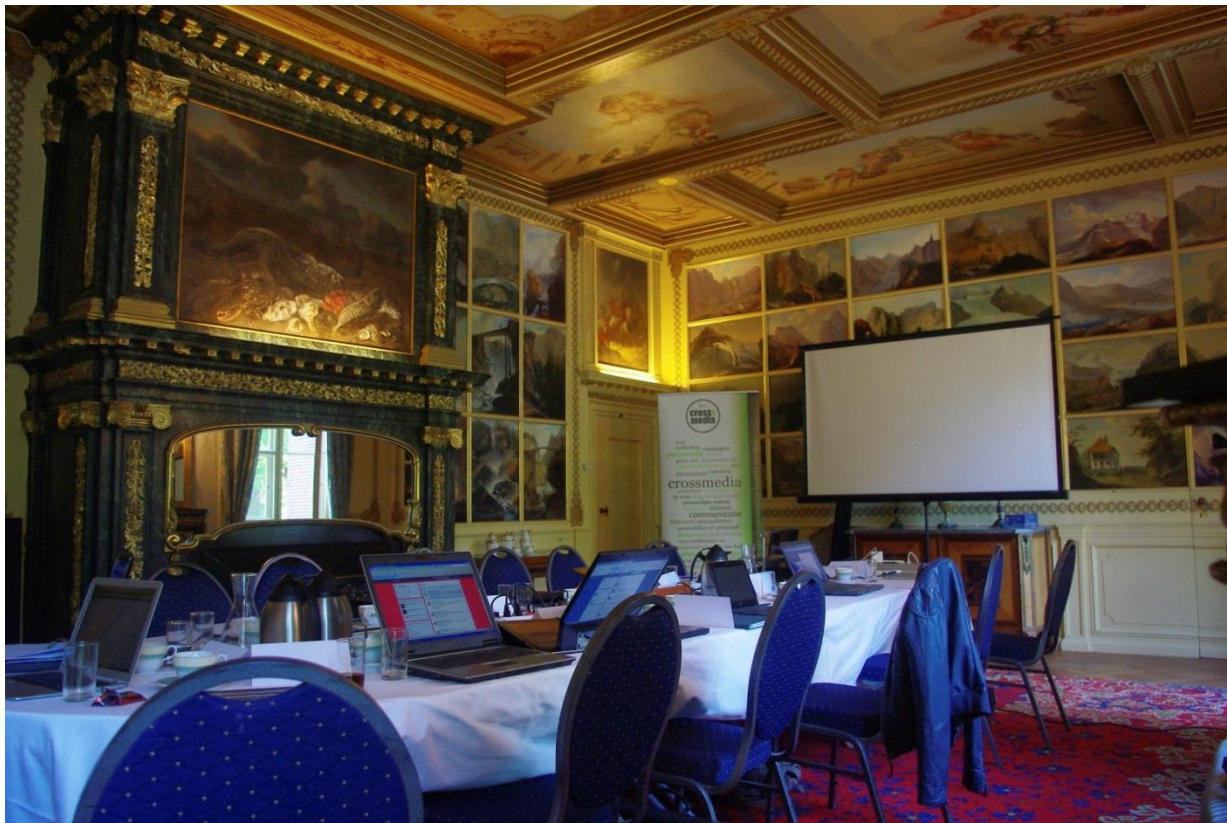
Fig. 3. Blue Salon after conservation. This room is now often in use for wedding and conferences. Here the large mantle piece is visible together with the ceiling paintings and the reinstalled replica eighteenth century Caspar Wolff landscape paintings. May 2012. ©E. Geldhof/R. Keppler

keep the room as found: a light colour scheme enhanced with three-dimensional decorations, painted on the beams and glued as linen strap-work on the wainscoting. A decoration scheme that the authors think captured the identity and synergy of the Blue Salon. (Figure 3) This outcome emphasises that personal prejudice and interpretation of paint analysis results can obscure proper understanding of the decorative synergy of a room.

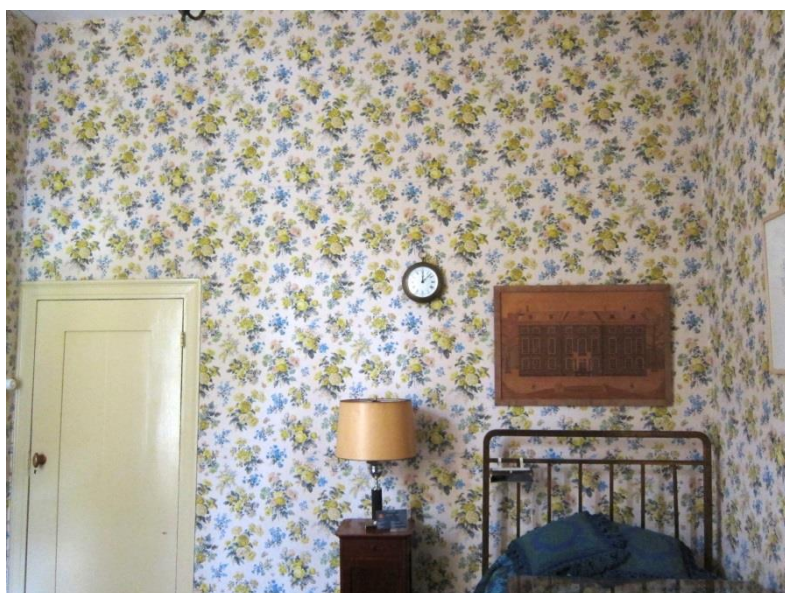
Fig. 4. Top: Count's Bedroom: after conservation. © E. Geldhof/R. Keppler

A comparable scenario unfolded in the Count's Bedroom. The conservation architect and castle administration followed a similar rigid strategy, attempting to return this interior to the 1860s building phase. The discovery of a tiny fragment of light blue wallpaper (found on a remnant of lattice-work beneath the existing flowery wallpaper) raised the expectation of an earlier decorative scheme. So the authors were asked about reproducing this wallpaper in order to return the room to an earlier historical vision. The blue paper fragment

was decorated with a now only slightly discernable trellis pattern, and closer examination failed to determine whether the scrap came from a wallpaper or border. Provenance, pattern and position were difficult to establish, and a convincing reconstruction was regarded as impossible.

This dearth of information allowed focus to shift to the existing wallpaper, a colourful paper depicting flowers, and the matching curtains. This more recent wallpaper had been deemed unacceptable and 'ugly' by the conservation architect and castle administration. But the authors had no idea why this wallpaper was considered ugly and wrong for the Count's Bedroom. The authors observed that the wallpaper was block-printed using a coherent pattern and was in excellent condition. (Figures 4 and 5) By happy coincidence, an unused roll of this wallpaper was found in the attic. This find enabled further research into the provenance of this wallpaper. The paper was hand printed in France by the wallpaper manufacturer Paul D{um}AS[2] in the pre-WWII period. The twelve-colour pattern was applied to *papier continu* that was of a good quality as rag fibres could be distinguished. When comparing the unused wallpaper with the paper on the walls, it was evident that the pattern on the walls had barely

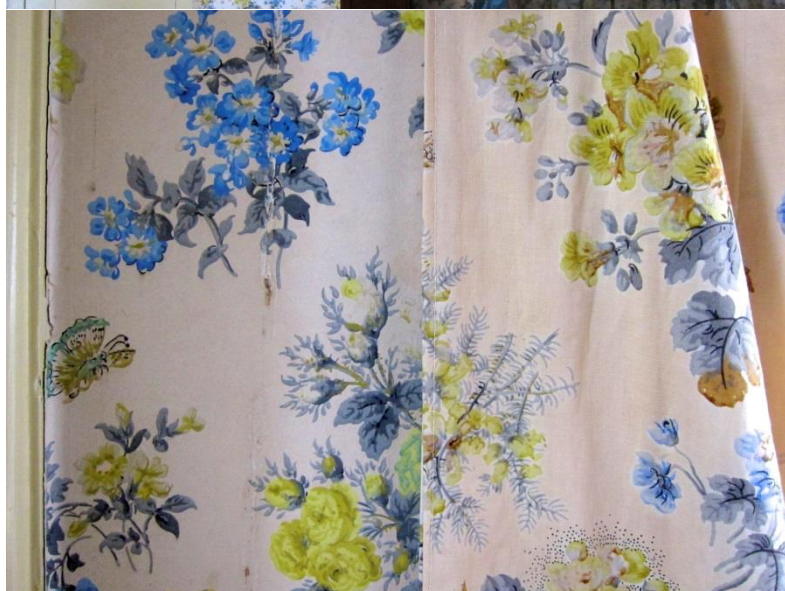
Fig. 5. Bottom: Count's Bedroom: detail of the wallpaper with matching curtains. © E. Geldhof/R. Keppler

faded. Knowing how the castle rooms were decorated in the 1920s and again around 1956, the authors presume that this flowery wallpaper in the Count's Bedroom was installed in the 1950's, but that it probably was manufactured in the pre-WWII period. The decoration in this room thus reflected the personal approach and taste of the count in the most personal room of the castle, his bedroom.

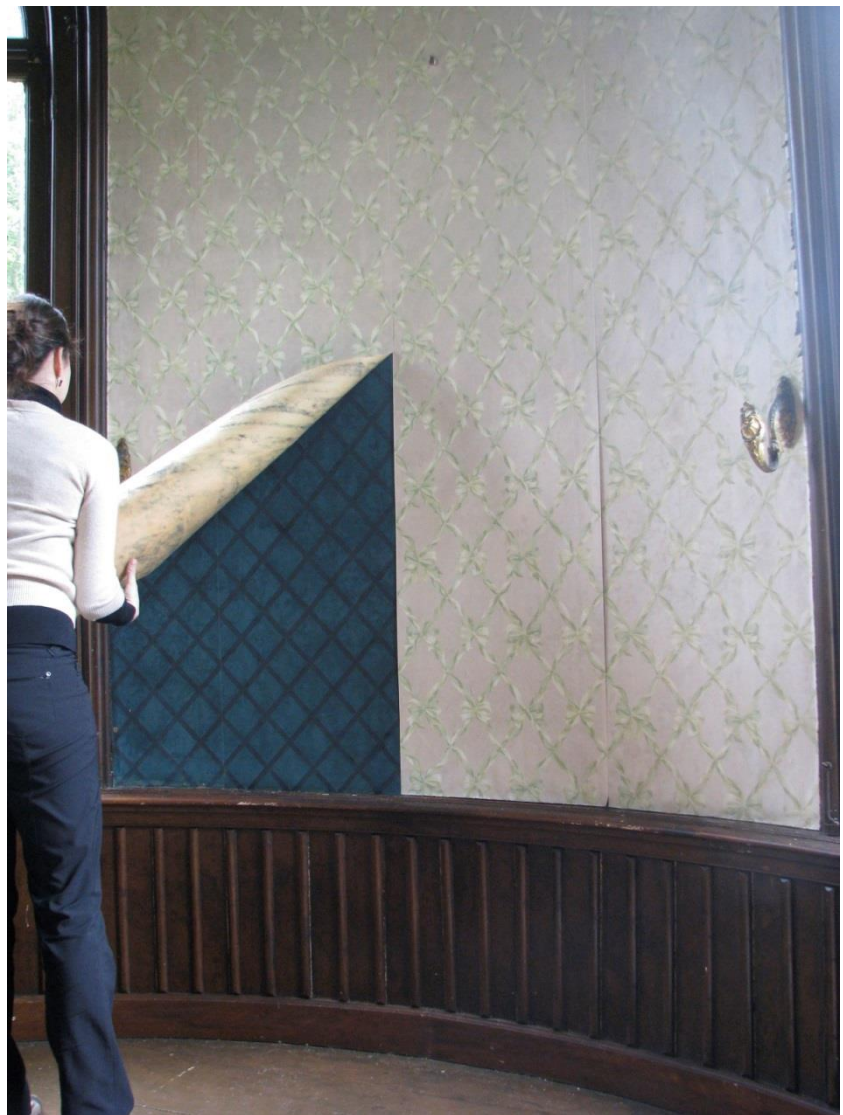
Fig. 6. Tower Room: wall with original 1860s wallpaper, and later 1950s wallpaper. ©E. Geldhof/R. Keppler

The round Tower Room, added to the existing villa around 1859 at the same time as the other towers, is situated on the first floor and has a vaulted stucco ceiling with a faux closed lantern. The ceiling is painted with a geometrical pattern of small squares in perspective, which are highlighted with gilding. This gilding, together with the gilded trim on the stucco cornice, glimmers beautifully in the sunlight. The plaster walls are wallpapered above a low wooden wainscoting, decorated in 1859 to imitate a dark wood grain, which is still preserved. The original 1860s wallpaper has a dark trellis motive with brown shadow lines on a dark blue-green background (Figure 6) and was papered over in the 1950s with a lighter wallpaper with a similar trellis pattern.

The Tower Room was refurbished as part of the 2008 conservation work (which for the Tower Room was limited to the conservation of the ceiling decoration). The original 1860s wallpaper was discovered during this work, hiding beneath the 1950s wallpaper. It seems that the 1950s wallpaper had been carefully chosen for this room, with its similar trellis pattern enhanced with light green bows against a very light silvery pearl-coloured background. However, the effect of this light wallpaper colour completely deprived the room of its original function and meaning.

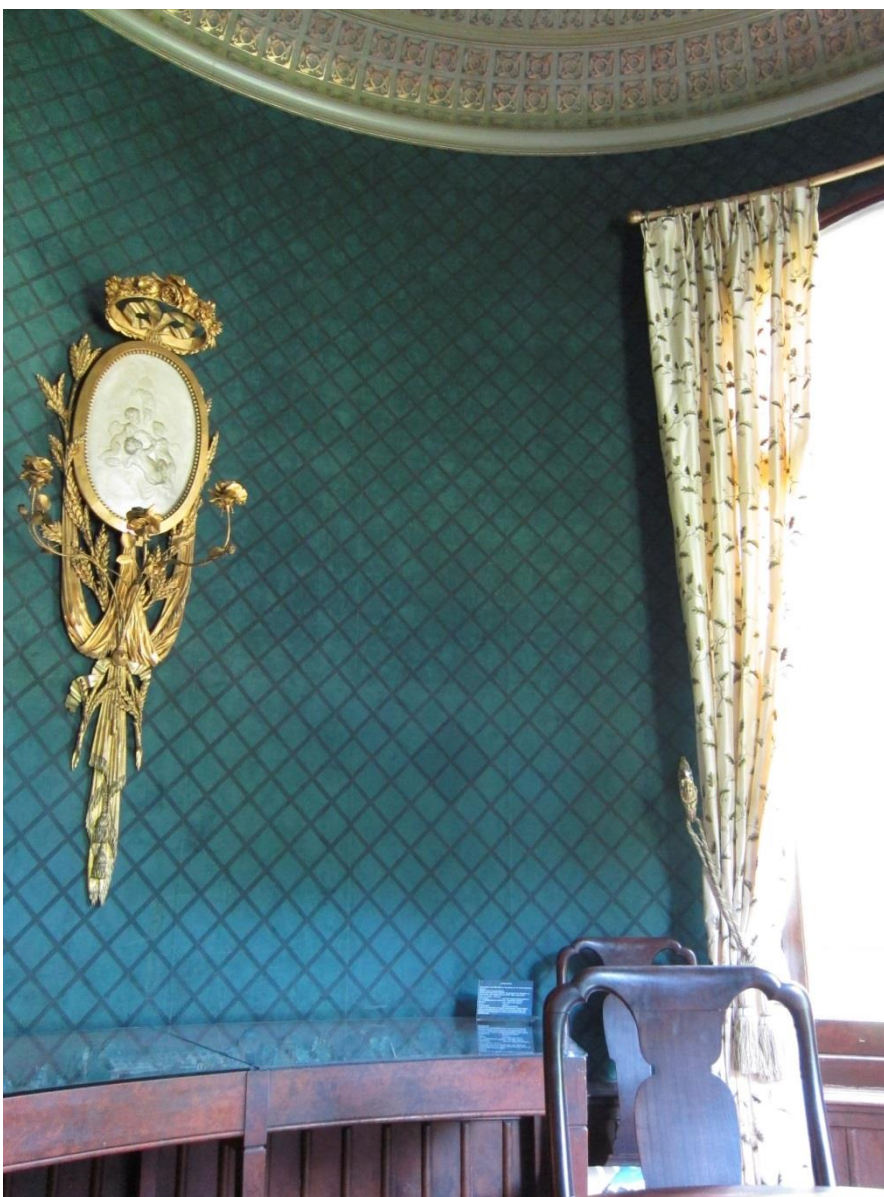
Fig. 7. Tower Room: after conservation. May 2012. ©E. Geldhof/R. Keppler

The main goal of the second conservation campaign in 2010 was to return the meaning and function of the Tower Room by uncovering the original wallpaper. In this case, there was sufficient time between 2008 and 2010 to carry out a pilot study. The pilot project allowed all stakeholders to assess the proposed result and see how the original appearance would work in reality. This allowed time to discuss treatment options and results before a long and complex treatment began. The function of the decorative scheme in the room as a binding element between the garden and the castle was explained by the

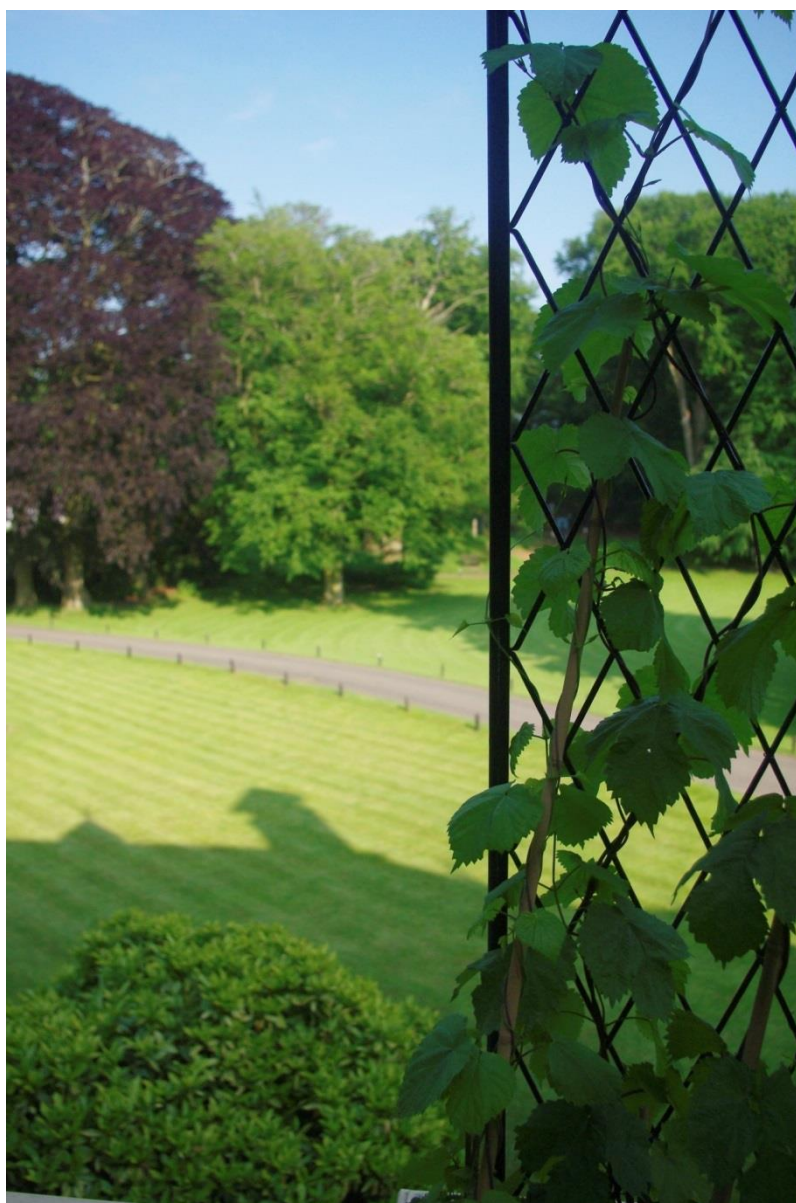
*Fig. 8. Detail 1860s pergola on the balcony of Kasteel Keukenhof, showing how the original trellis wallpaper would have worked in the Tower Room.
©E. Geldhof/R. Keppler*
